Operation Inspection Report
for
Department of Energy

Date of Inspection September 21, 1994

Dam Name Dams A-4, B-5 & C-2

Department of Energy (Facility Name) Rocky Flats

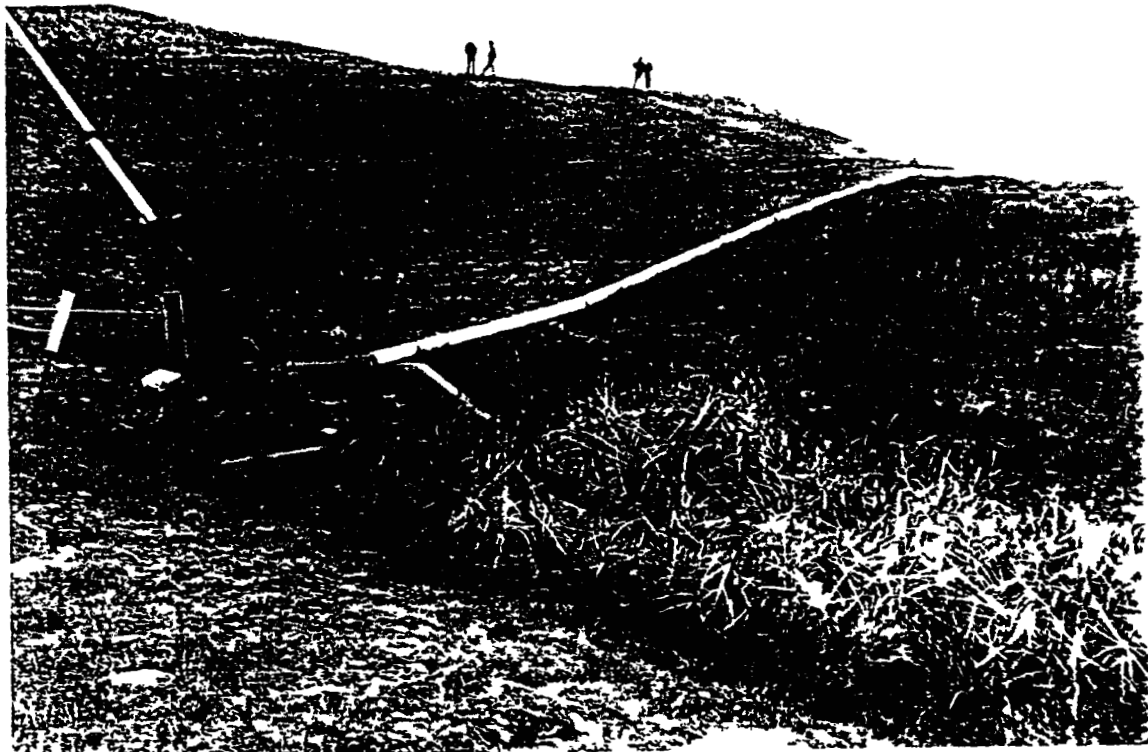
The outlet works consists of an 18-inch (46 cm) reinforced concrete pipe (RCP) which discharges into a concrete stilling basin. Heavy vegetative growth in and around the outlet structure (Photo 9) prevented the observation of any telltale signs of piping around the outlet pipe. The visible portion of the structure however appeared in a good condition. No cracks or spalls in the concrete were noted. The outlet works channel also had heavy vegetation growth (Photo 10). The shut-off gate is located at the downstream end of the conduit. This is not a desirable feature since the conduit is continuously pressurized which greatly increases the risk of leakage through pipe joints which could cause piping along the outside of the conduit.

Photo 9 View of Outlet Works of Pond A-4 Dam Note heavy vegetation

(1) Heavy vegetation growth in the outlet structure area prevents proper inspection for piping along the outlet pile. This as well as vegetation on the upstream face near the crest level should be cut back.

(3) It is recommended that the existing outlet gate be operated on an annual basis. Also an outlet works gate should be installed on the upstream side of the outlet works to reduce risk of piping along the outside of the conduit.

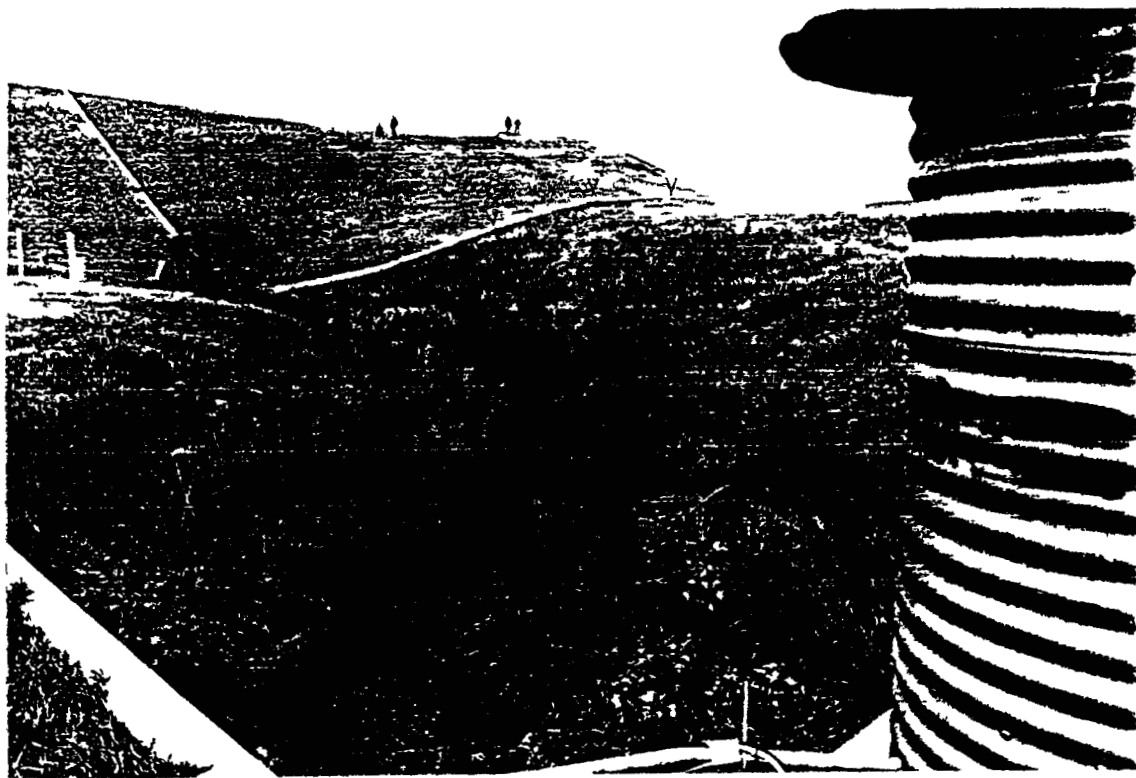
Photo 10 View of Outlet Works Channel Full of vegetation

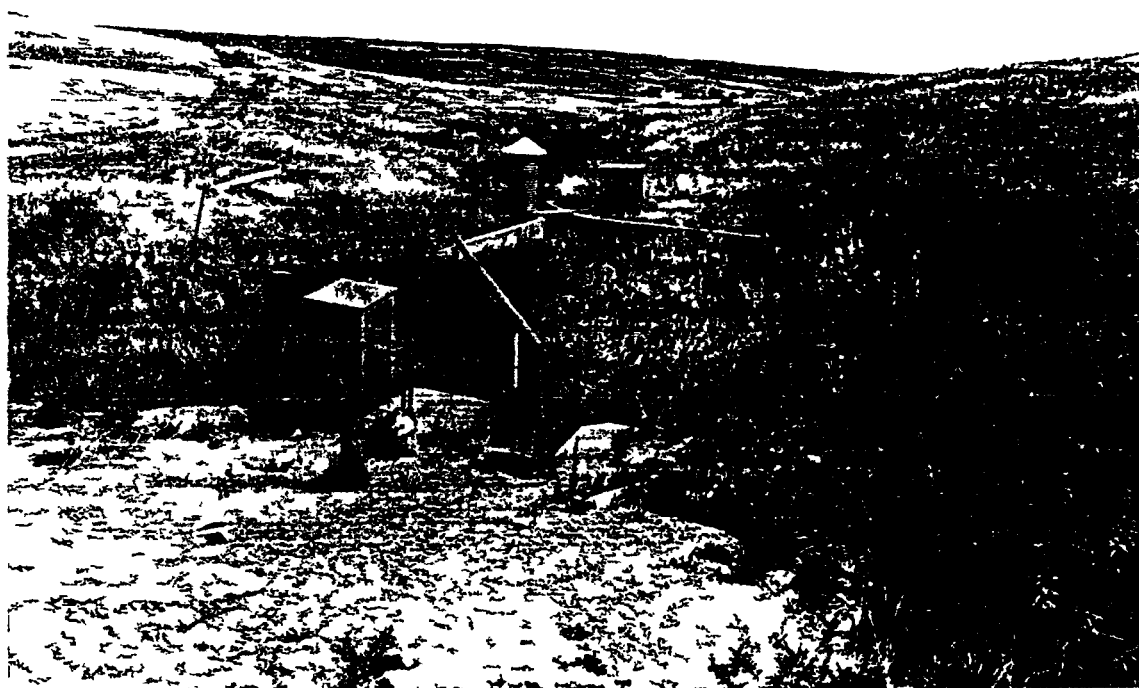
As for Dam A-4, excessive vegetation was also observed near the outlet area and the channel (Photos 14 & 15) The concrete of the outlet structure appeared to be in a good condition

Photo 14 View of the Outlet Works of Pond B-5 Dam looking north east

Photo 15 Another view of the outlet works looking south west
The loose soil seen is from installation of
piezometer

(1) Excessive vegetation growth exists in and around the outlet structure. It should be cut back.

(3) An upstream gate for the outlet conduit should be installed and the existing downstream gate be operated on annual basis.

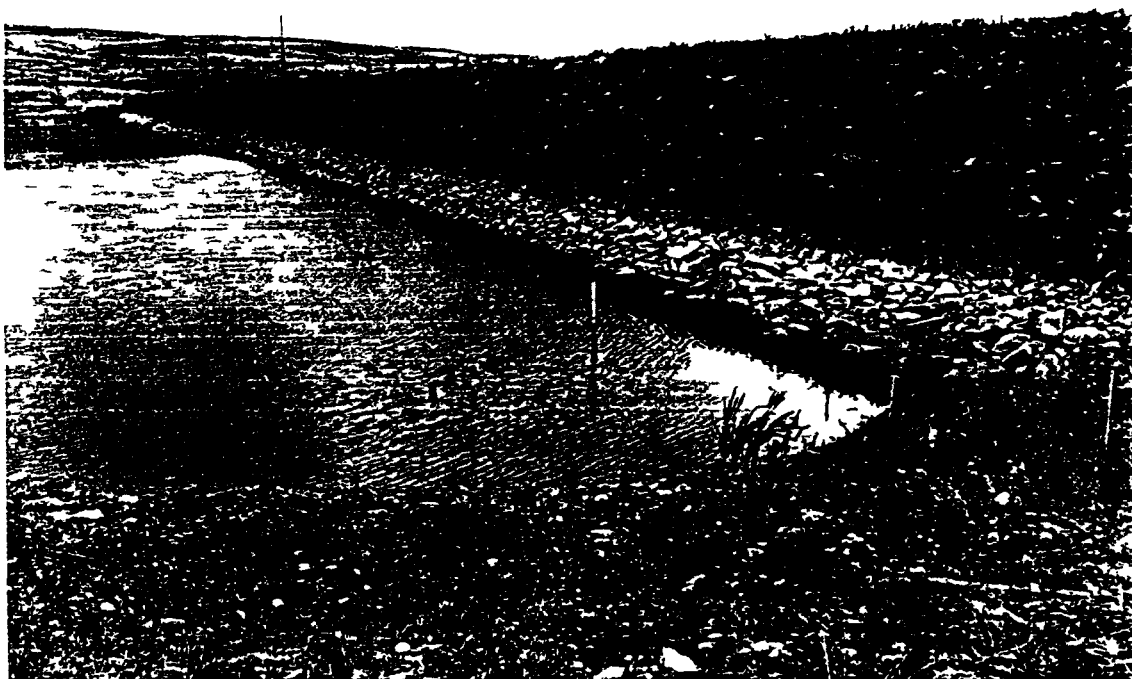
Photo 17 View of upstream slope of Pond C-2 Dam looking north east Slope lines appeared neat with no visible degradation

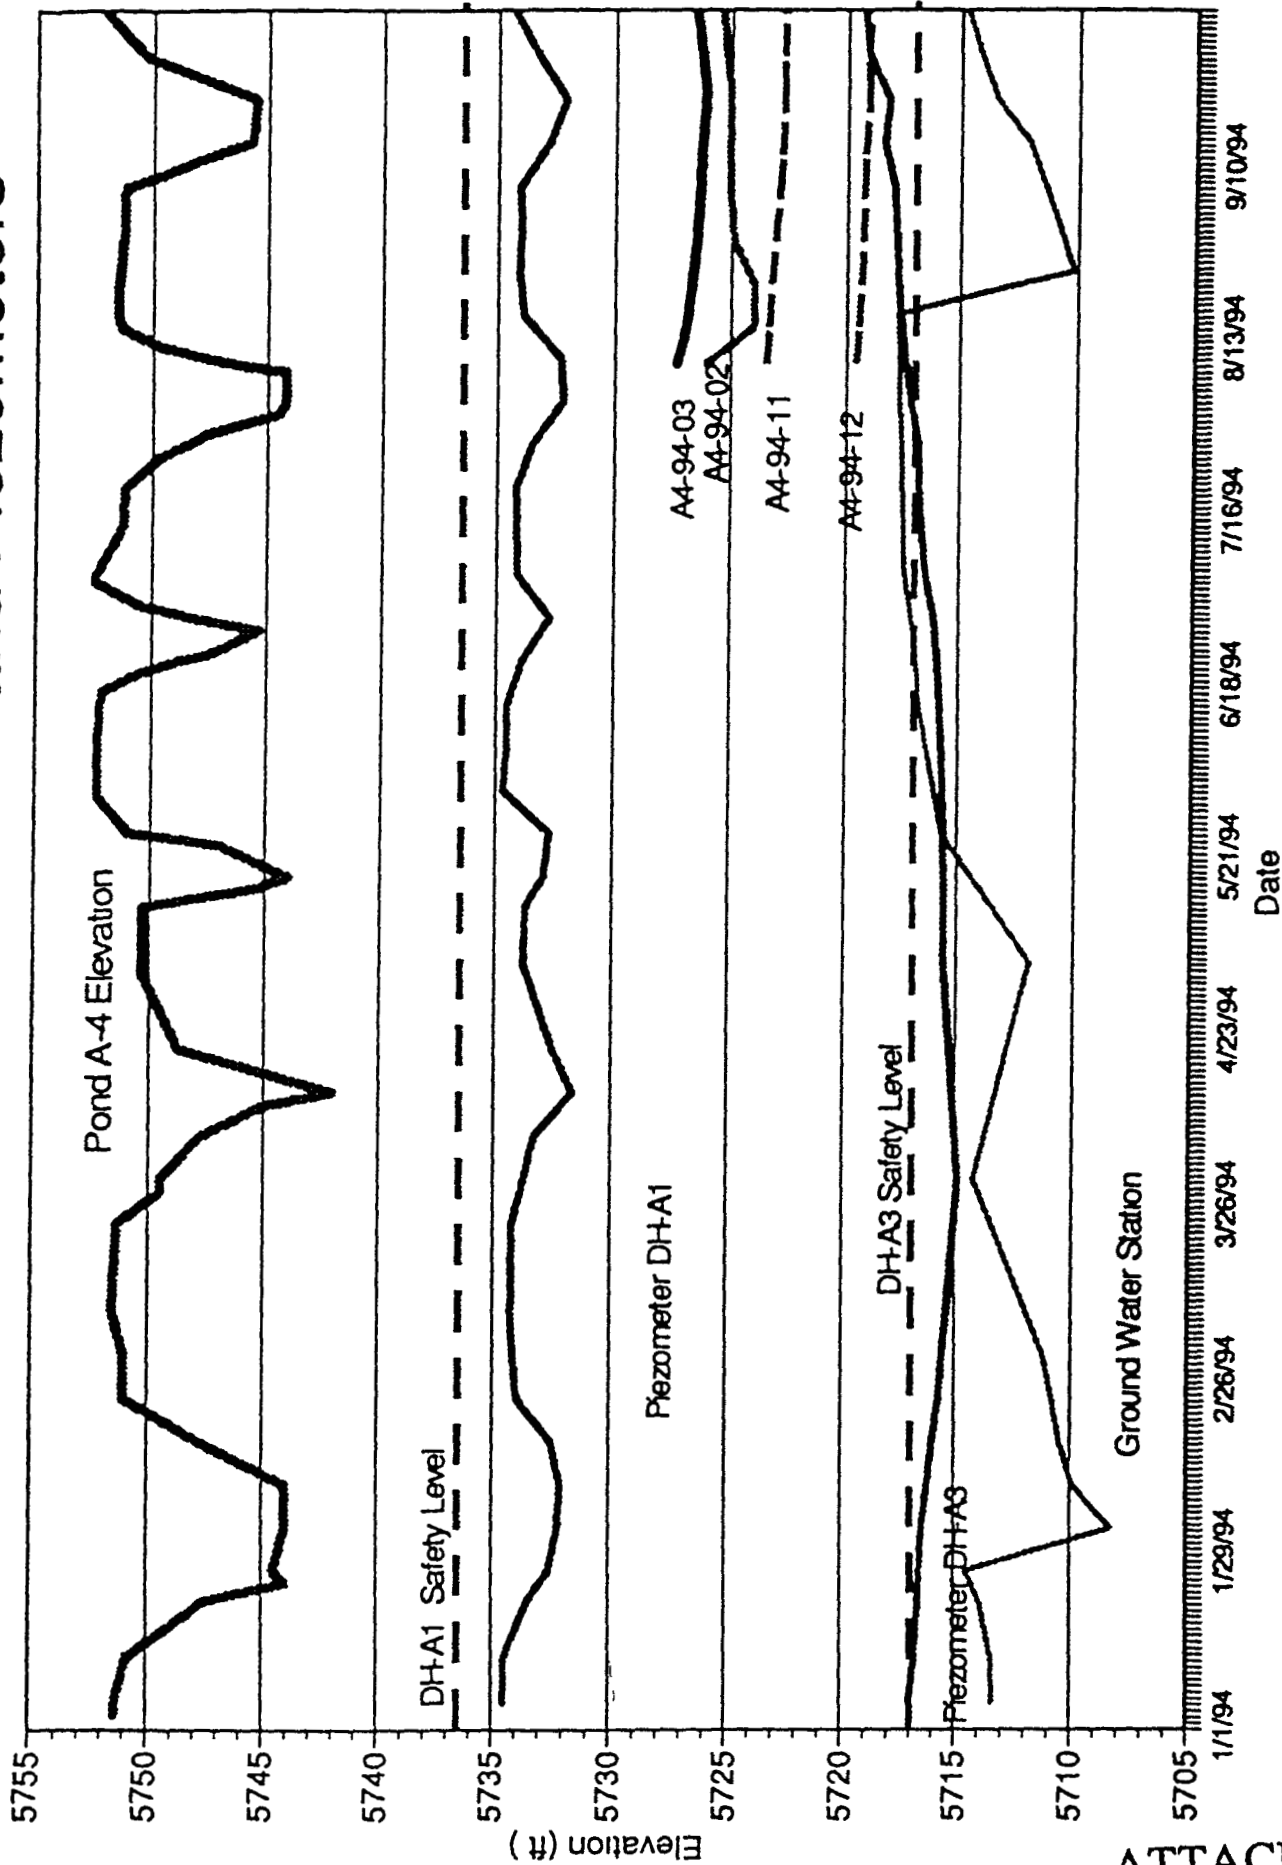
1994 Elevations of Pond A-4 and Piezometers

Dam A-4 Four new piezometers were installed in July 1994 Two of these A4-94-02 and A4-94-03 are at the crest and the other two A4-94-11 and A4-94-12 are at the toe of the dam Enough data from these four piezometers have not been collected to indicate any definite correlation with the pond level In fact during the period of 8/8/94 to 8/15/94 the reservoir level rose by 7 feet, but the piezometer readings did not respond Actually for A4-94-03 it went down by a couple of feet We shall need to have more data before any conclusions can be drawn Perhaps the instruments also need to be checked to see if these are functioning properly

The reservoir levels indicate that the reservoir was being operated at substantially higher capacity and over a longer period of time during the data period than originally intended The highest elevation has been as high as 54% full

Piezometer DH-A1 is on the crest of the dam, and Piezometer DH-A3 is on the toe of the dam. Both are centrally located. The Groundwater station is on the toe of the dam, approximately 100 yards north of the dam's center. A4-94-02 is dry measurement indicates bottom of well, fluctuations may be caused by human error measuring line slack

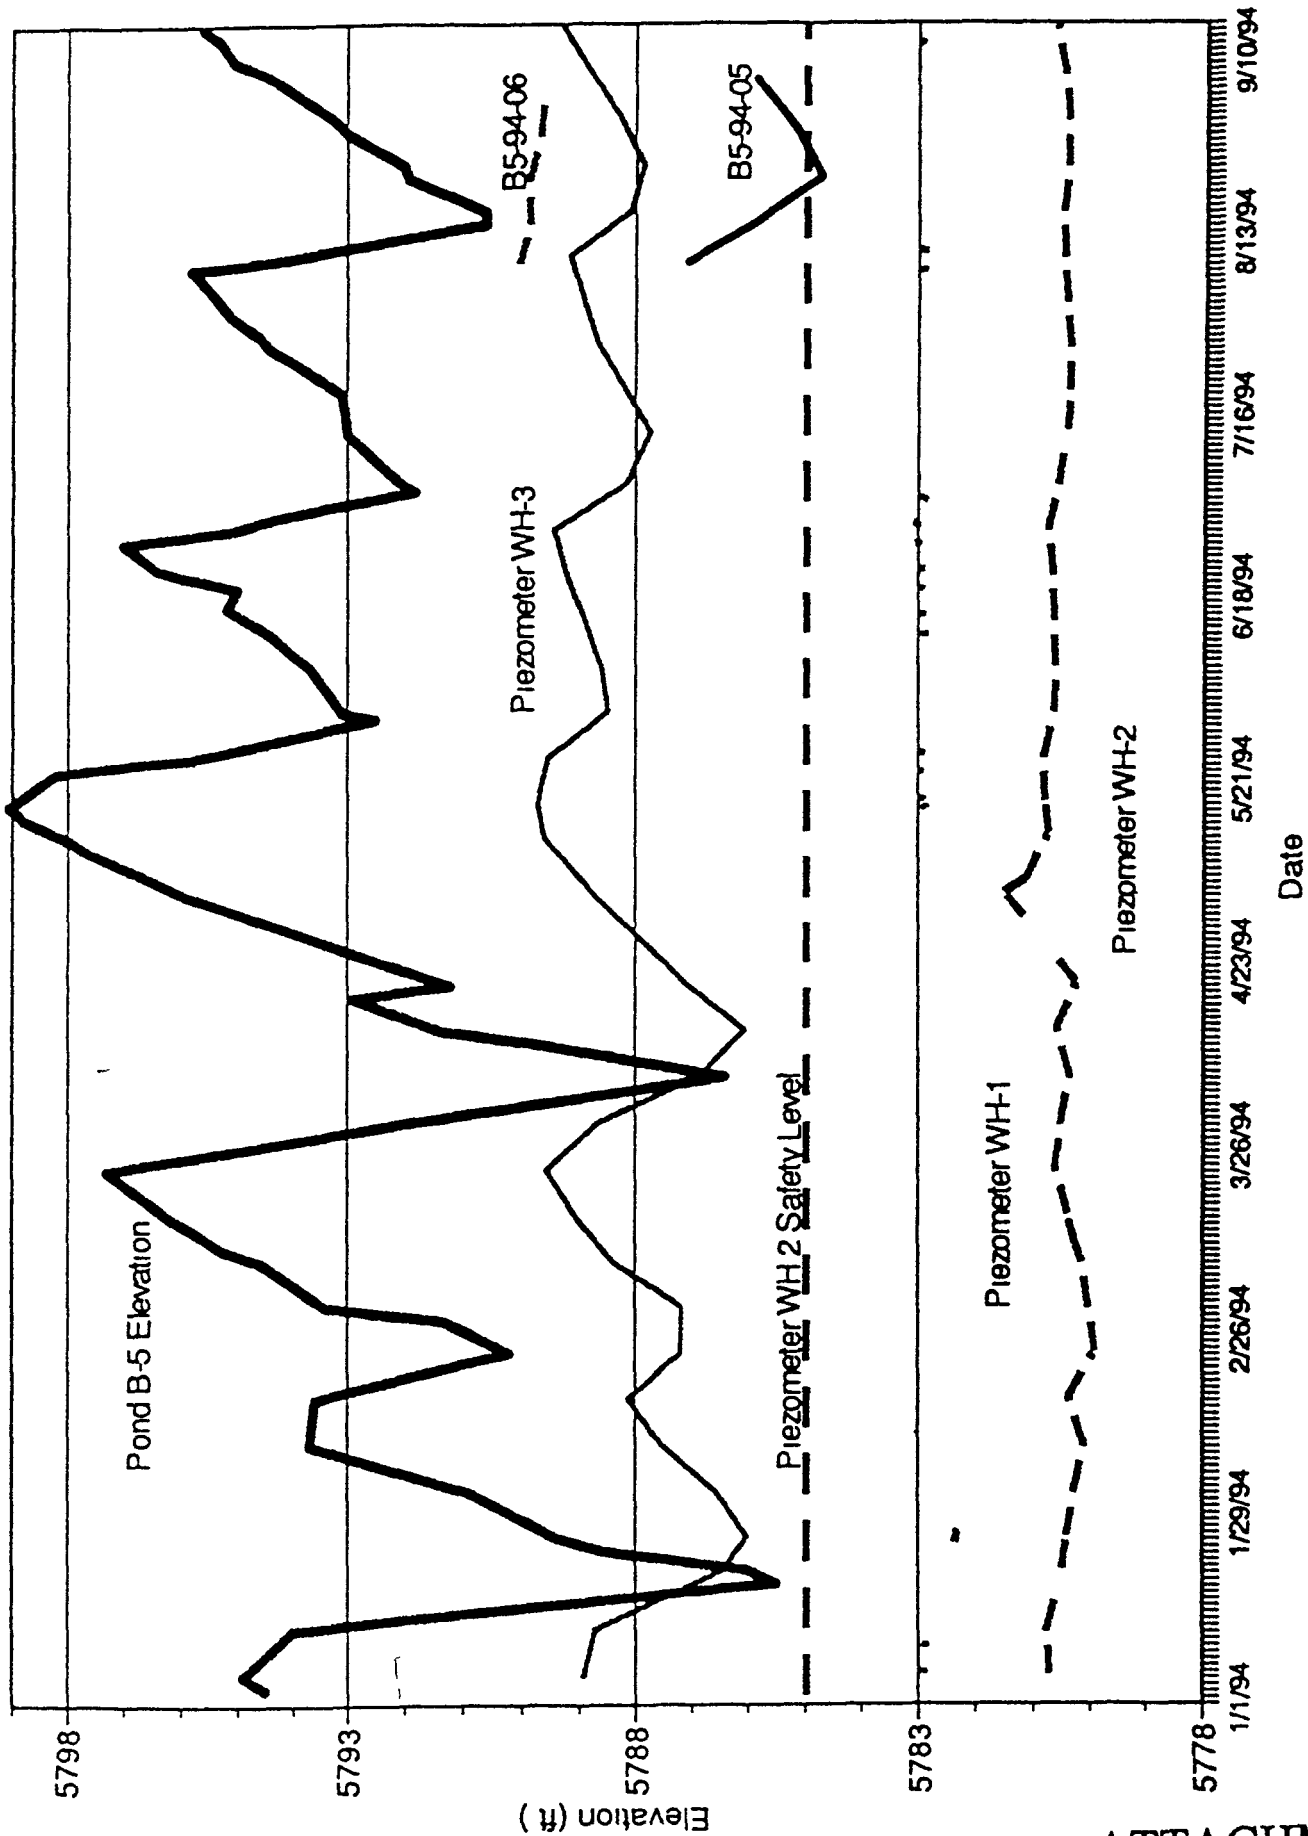
1994 Elevations of Pond B-5 and Crest Piezometers

As for Dam A-4 the reservoir levels indicate that the reservoir was being operated at higher capacity than originally intended The highest elevation has been as high as 60% full

Piezometer WH-2 is the central crest piezometer Piezometers WH-1 and WH-3 are located north and south of Piezometer WH-2, respectively

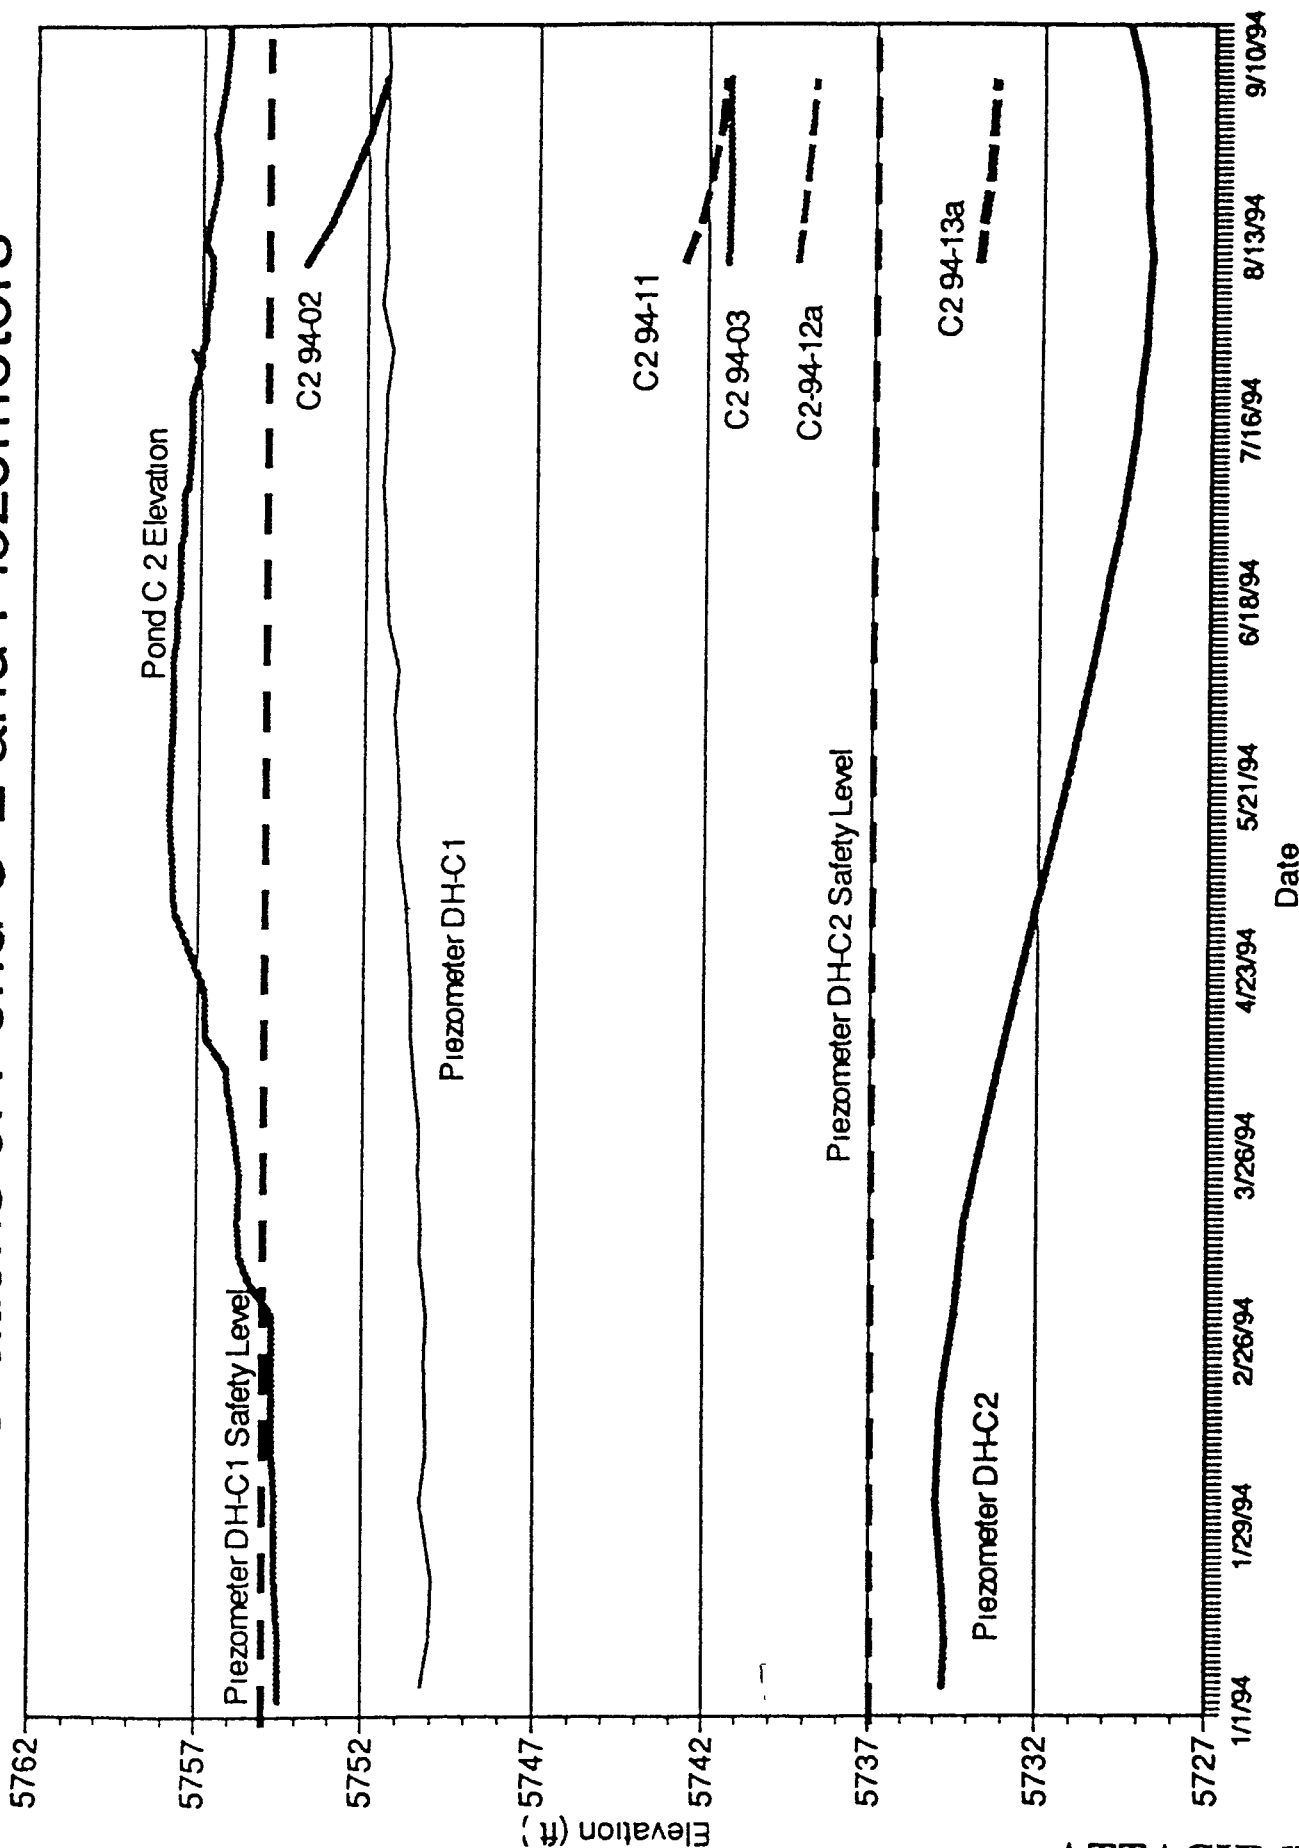
1994 Elevations of Pond C-2 and Piezometers

The reservoir levels for Dam C-2 have also been higher than originally intended. The highest elevation has been as high as 33% full.

Piezometer DH-C1 is on the crest of the dam, and Piezometer DH-C2 is on the toe of the dam. Both are centrally located
